**Flood Control Project Maintenance
Levee Inspections**

Fall 2016 Levee Maintenance Deficiency Summary Report

Sacramento River Basin

Sutter Maintenance Yard Maintenance Area 0001

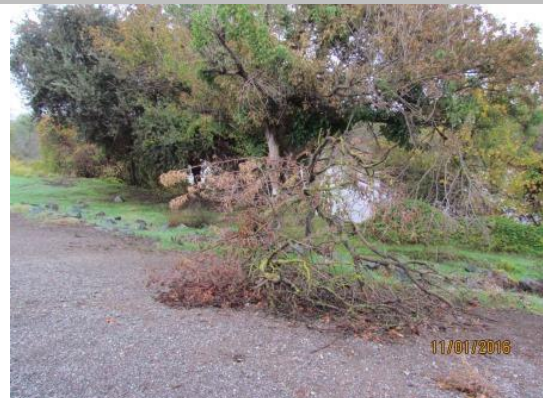
Photo 1 of 1 : FA_2016_MA0001_297_93_20161104_00151.jpg

View of a tree limb along the waterside slope.

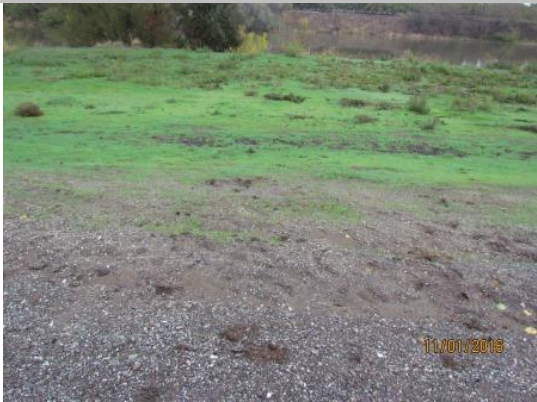
Photo 1 of 1 : FA_2016_MA0001_297_96_20161104_00154.jpg

View of the erosion along the waterside slope.

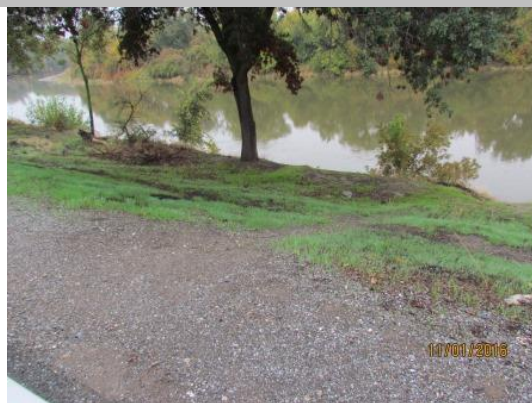
Photo 1 of 1 : FA_2016_MA0001_297_98_20161104_00155.jpg

LM Start	0.38	Rating **	M	Issue No.	98
LM End	0.38	Issue Type +	Ma	Location *	WS
Category	Earthen Levee			GPS Latitude/Longitude	
				Start	End
Item	Slope Stability			39.215878 °	39.215878 °
				-122.007278 °	-122.007278 °
DWR ID	DWR_MA0001_01_f_2016_98				
Comment Code					
S2 : Repair the levee slope damaged by foot traffic and prevent access where possible.					
Inspector Comment

View of the slope instability along the waterside slope.

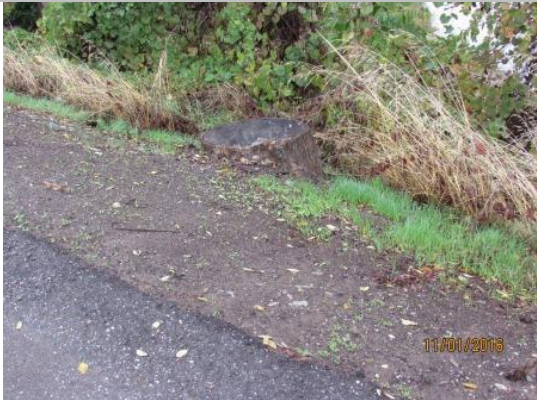
Photo 1 of 1 : FA_2016_MA0001_297_103_20161104_00159.jpg

View of a tree stump along the waterside slope.

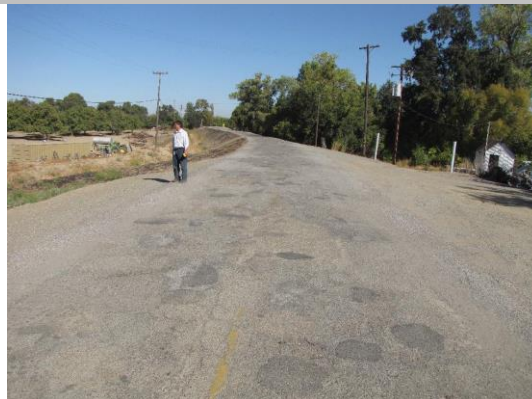
Photo 1 of 2 : UCIP_FA_2016_50463_70052.jpg

UCIP Comments: 10/24/2016 LS still rusted/corroded. WS appears in good condition.(DWR Sutter Yard- A Freitag)4/25/2016 LS pipe outlet is rusted and corroded. Wood debris on WS has been removed and erosion on toe road was repaired.4/20/2015 Same as last inspection. No repairs have been made yet. 6/18/2014 Same as last inspection.12/17/2013 Same as last inspection.7/18/2013 LS outlet was underwater and could not be inspected but nothing looks to have been changed.10/18/2012 Need pressure test/video inspection to determine integrity of pipe wall. WS-woody debris scattered along slope & bank. Erosion on bank near ditch. LS-discharge pipe heavily corroded & CMP section missing. This crossing was listed in the USACE Periodic Inspections as ID# USACE_CESPK_MA1C_2010_p_0097 for debris & encroachment within 15 feet.

Overview of levee crown at crossing looking U/S.

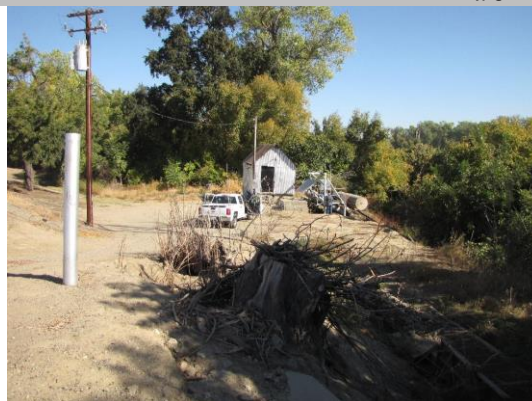
Photo 2 of 2 : UCIP_FA_2016_50463_70051.jpg

Item	DWR UCIP Field Study			39.221685 °	39.221685 °	
				-122.015720 °	-122.015720 °	
DWR ID						
Comment Code						
Inspector Comment						
FS_ID:50463 DS_ID:16431 EP_NO: 9481 Repair Type: Non-Urgent Crossing Status: Found UCIP Comments: 10/24/2016 LS still rusted/corroded. WS appears in good condition.(DWR Sutter Yard- A/Freitag)4/25/2016 LS pipe outlet is rusted and corroded. Wood debris on WS has been removed and erosion on toe road was repaired.4/20/2015 Same as last inspection. No repairs have been made yet. 6/18/2014 Same as last inspection.12/17/2013 Same as last inspection.7/18/2013 LS outlet was underwater and could not be inspected but nothing looks to have been changed.10/18/2012 Need pressure test/video inspection to determine integrity of pipe wall. WS-woody debris scattered along slope & bank. Erosion on bank near ditch. LS-discharge pipe heavily corroded & CMP section missing. This crossing was listed in the USACE Periodic Inspections as ID# USACE_CESPK_MA1C_2010_p_0097 for debris & encroachment within 15 feet. FIELD_STRUCT_DESC: 36-inch corrugated metal irrigation pipe through the levee at unknown depth below the crown. Slide gate is located on the waterside (WS) slope. Crossing penetrates the levee at an angle. Other appurtances located at this crossing include slant pump, concrete distribution box and shed structure located 100 feet northeast from levee crossing. Flow is carried from concrete distribution box to slide gate via concrete lined ditch. Outlet is visible on the landside (LS). (Automatic Board Order (ABO) issued as Permit No. 9481, 1974 - Roberts Ditch Irrigation Company) [Additional Reference(s): DWR Levee Log, 1992. USACE Sacramento O&M Manual 137, August 1955, (Station 63+53)]. FS Date: 10/27/2016 8:40:49 AM

Other appurtenances associated with crossing-Structure, pump, distribution box, and power pole located on WS bank.

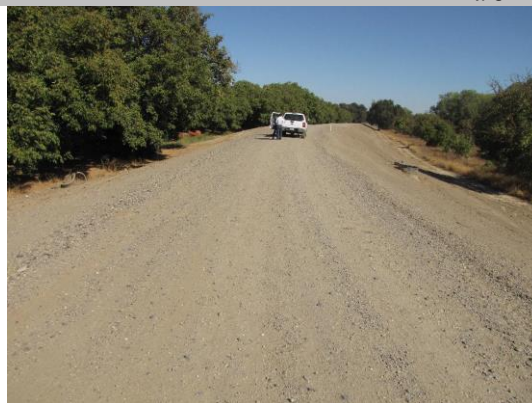
Photo 1 of 2 : UCIP_FA_2016_50465_70064.jpg

Comment Code					
Inspector Comment					
FS_ID:50465 DS_ID:16430 EP_NO: 9487 Repair Type: Non-Urgent Crossing Status: Found UCIP Comments: 10/24/2016 Ws end is till partially plugged.(DWR Sutter Yard- AFreitag)4/25/2016 WS pipe end is still plugged with soil. Rest of the pipe appeared to be in good condition.4/20/2015 WS pipe end is plugged about 50% by soil.6/18/2014 Same as last inspection.12/17/2013 Same as last inspection.7/18/2013 WS pipe end has been reformed but is still clogged about 50% by sediment.10/18/2012 Remove dirt and debris in riser. Outlet deformed and blocked over 50%. Debris-round concrete section on landward side. This crossing was listed in the USACE Periodic Inspections as ID# USACE_CESPK_MA1C_2010_p_0116 for crossing outlet deformed and clogged with dirt. FIELD_STRUCT_DESC: 1 of 2: 36-inch corrugated metal drainage pipe through the levee, approximately 12-15 feet below the crown. Slide gates in corrugated metal pipe (CMP) riser located on the waterside (WS) slope. Pipe daylights on the landside (LS). (Automatic Board Order (ABO) issued as Permit No. 9487, 1974 - Jimeno Rancho) [Additional Reference(s): DWR Levee Log, 1992. USACE Sacramento O&M Manual 137, August 1955, (Station 103+18)]. FS Date: 10/27/2016 8:51:12 AM

Overview of levee crown and slopes looking upstream towards crossing.

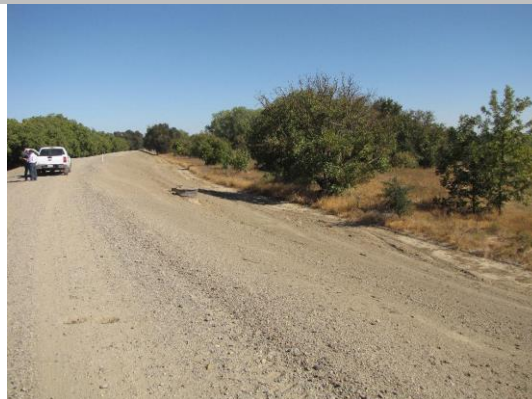
Photo 2 of 2 : UCIP_FA_2016_50465_70063.jpg

Item	DWR UCIP Field Study			39.231866 °	39.231866 °	
				-122.015442 °	-122.015442 °	
DWR ID						
Comment Code						
Inspector Comment						
FS_ID:50465 DS_ID:16430 EP_NO: 9487 Repair Type: Non-Urgent Crossing Status: Found UCIP Comments: 10/24/2016 Ws end is till partially plugged.(DWR Sutter Yard- AFreitag)4/25/2016 WS pipe end is still plugged with soil. Rest of the pipe appeared to be in good condition.4/20/2015 WS pipe end is plugged about 50% by soil.6/18/2014 Same as last inspection.12/17/2013 Same as last inspection.7/18/2013 WS pipe end has been reformed but is still clogged about 50% by sediment.10/18/2012 Remove dirt and debris in riser. Outlet deformed and blocked over 50%. Debris-round concrete section on landward side. This crossing was listed in the USACE Periodic Inspections as ID# USACE_CESPK_MA1C_2010_p_0116 for crossing outlet deformed and clogged with dirt. FIELD_STRUCT_DESC: 1 of 2: 36-inch corrugated metal drainage pipe through the levee, approximately 12-15 feet below the crown. Slide gates in corrugated metal pipe (CMP) riser located on the waterside (WS) slope. Pipe daylights on the landside (LS). (Automatic Board Order (ABO) issued as Permit No. 9487, 1974 - Jimeno Rancho) [Additional Reference(s): DWR Levee Log, 1992. USACE Sacramento O&M Manual 137, August 1955, (Station 103+18)]. FS Date: 10/27/2016 8:51:12 AM

View of WS looking upstream at CMP riser on slope.

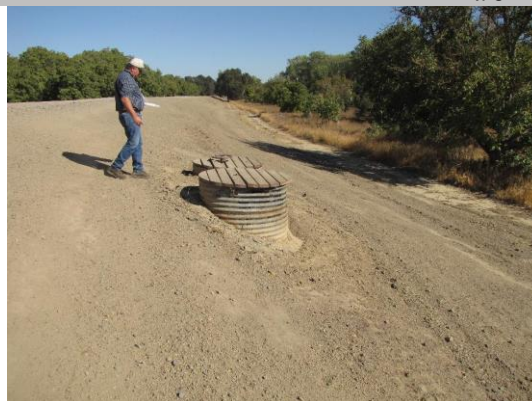
Photo 2 of 2 : UCIP_FA_2016_50466_70074.jpg

FS_ID:50466
DS_ID:17565
EP_NO: 9487
Repair Type: Non-Urgent
Crossing Status: Found
UCIP Comments: 10/24/2016 Ws pipe end still plugged.(DWR Sutter Yard- AFreitag)4/25/2016 WS pipe end still plugged with soil. rest of pipe appears in good condition.4/20/2015 WS pipe end plugged about 50% by soil.6/18/2014 Same as last inspection.12/17/2013 Same as last inspection.7/18/2013 WS pipe end has been reformed but is still partially blocked with dirt and debris.10/18/2012 WS-remove dirt and debris in riser. Outlet deformed and blocked over 50%. Burrow activity near outlet on waterward slope. Debris around concrete section on landward side. This crossing was listed in the USACE Periodic Inspections as ID# USACE_CESPK_MA1C_2010_p_0116 for crossing outlet deformed and clogged with dirt.
FIELD_STRUCT_DESC: 2 of 2: 36-inch corrugated metal drainage pipe through the levee, approximately 12-15 feet below the crown. Slide gates in corrugated metal pipe (CMP) riser on the waterside (WS) slope. Pipe daylights on the landside (LS). (Automatic Board Order (ABO) issued as Permit No. 9487, 1974 - Jimeno Rancho) [Additional Reference(s): DWR Levee Log, 1992. USACE Sacramento O&M Manual 137, August 1955, (Station 103+18)].

View of CMP risers located on WS slope.

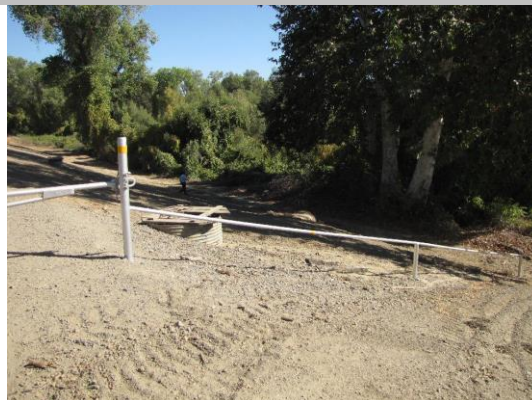
Photo 2 of 2 : UCIP_FA_2016_50467_70079.jpg

FS_ID:50467
DS_ID:16429
EP_NO: 9472
Repair Type: Non-Urgent
Crossing Status: Found
UCIP Comments: 10/24/2016 Debris still inside of riser.(DWR Sutter Yard- AFreitag)4/25/2016 Pipe still inside of riser and LS end plugged about 50% by soil.4/20/2015 Same as last inspection.6/18/2014 Same as last inspection.12/17/2013 Same as last inspection.7/18/2013 Same as last inspection.10/18/12 Remove debris from riser. Landward inlet is blocked by over 50%. This crossing was listed in the USACE Periodic Inspections as ID# USACE_CESPK_MA1C_2010_p_0128 for sediment build up at inlet (landward side) and debris inside riser.
FIELD_STRUCT_DESC: 54-inch corrugated metal drainage pipe through the levee, approximately 12-15 feet below the crown. Slide gate in corrugated metal pipe (CMP) riser on the waterside (WS) slope. 48-inch CMP at landside (LS) slope. This crossing crosses the levee at an angle. (Automatic Board Order (ABO) issued as Permit No. 9472, 1974 - Ballard) [Additional Reference(s): DWR Levee Log, 1992. USACE Sacramento O&M Manual 137, August 1955, (Station 120+00)].

View of WS looking at slope and channel.

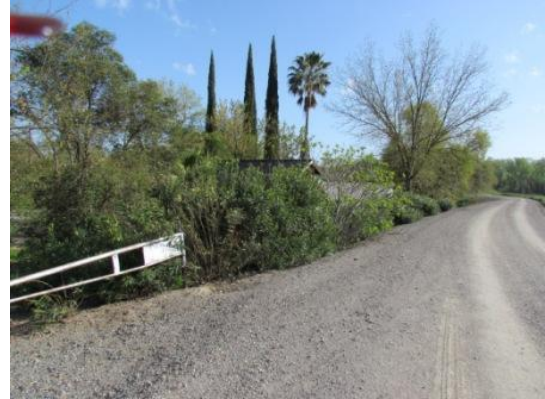
Photo 1 of 1 : FA_2016_MA0001_297_20_20160823_00010.jpg

View of the house next to the levee.

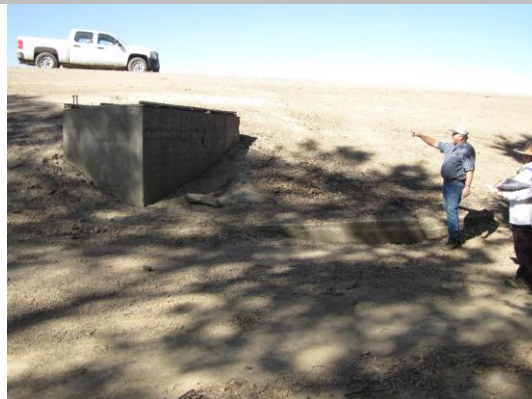
Photo 2 of 2 : UCIP_FA_2016_50470_70094.jpg

FS_ID:50470
DS_ID:16416
EP_NO: 9474
Repair Type: Non-Urgent
Crossing Status: Found
UCIP Comments: 10/24/2016 Appears to be abandoned. WS vault full of soil to help prevent water from flowing through during high water season.(DWR Sutter Yard- AFreitag)4/25/2016 Concrete box was filled with dirt to help prevent water from through during high water times.4/20/2015 Positive closure device is missing and water cannot be prevented from flowing through pipe during high water. 6/18/2014 Same as last inspection.12/17/2013 Same as last inspection.7/18/2013 Same as last inspection.10/18/12 During high water flow goes through levee. Missing positive closure device on waterward side. This structure appears abandoned-slide gates have been removed. Crossing needs to be properly abandoned. This crossing was listed in the USACE Periodic Inspection as ID# USACE_CESPK_MA1C_2010_p_0169 for concrete box partially filled with dirt.

View of concrete distribution box and headwall located on WS.

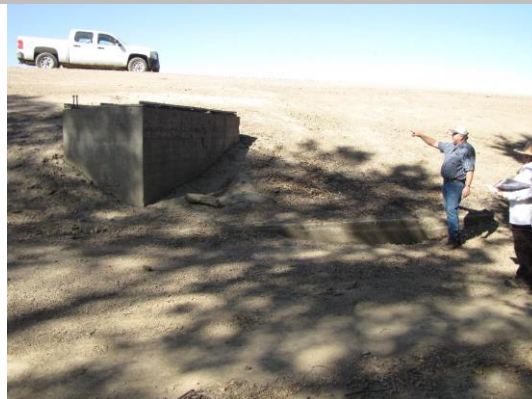
Photo 2 of 2 : UCIP_FA_2016_50471_70107.jpg

FS_ID:50471
DS_ID:17567
EP_NO: 9474
Repair Type: Non-Urgent
Crossing Status: Found
UCIP Comments: 10/24/2016 Appears to be abandoned. WS vault full of soil to help prevent water from flowing through during high water season.(DWR Sutter Yard- AFreitag)4/25/2016 Concrete box on WS was filled with soil to help prevent water from flowing through during times of high water.4/20/2015 Positive closure device is missing and water cannot be prevented from flowing through pipe during high water.6/18/2014 Same as last inspection.12/17/2013 Same as last inspection.7/18/2013 Same as last inspection.10/18/2015 During high water flow goes through levee. Missing positive closure device on waterward side. This structure appears abandoned-slide gates have been removed. Crossing needs to be properly abandoned. This crossing was listed in the USACE Periodic Inspection as ID# USACE_CESPK_MA1C_2010_p_0169 for concrete box partially filled with dirt.

Concrete distribution box and headwall located on WS.

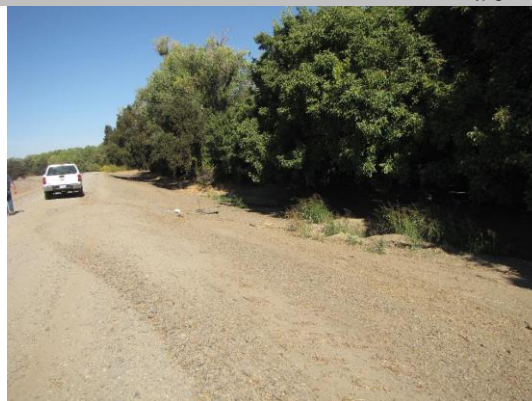
Photo 2 of 2 : UCIP_FA_2016_50473_70109.jpg

FS_ID:50473
DS_ID:16426
EP_NO: 9490
Repair Type: Non-Urgent
Crossing Status: Found
UCIP Comments: 10/24/2016 WS slide gate stem is still bent.(DWR Sutter Yard- A/Freitag)4/25/2016 WS slide gate is slightly bent. Rest of crossing appears to be in good condition. 4/20/2015 LS inlet still has some minor sediment build up. Needs to be cleaned.6/18/2014 Same as last inspection.12/17/2013 Same as last inspection.7/18/2013 WS slide gate looks to be in good condition but stem is slightly bent. Not sure if bend will hinder gates operation or not. LS inlet is still blocked by minor sediment build up.10/18/2012 LS pipe slightly deformed and sediment build up blocking about 30% of opening; need to check the condition of the slide gate-need photo. Metal marker down. This crossing was listed in the USACE Periodic Inspection as ID# USACE_CESPK_MA1C_2010_p_0187 for sediment build up at landward toe.
FIELD_STRUCT_DESC: 36-inch corrugated metal drainage pipe through the levee, approximately 12-15 feet below the crown. Slide gate in corrugated metal pipe (CMP) riser on the waterside (WS) slope. (Permit No. 9490, 1955 - Charles & Virginia Yerxa) [Additional Reference(s): DWR Levee Log, 1992. USACE Sacramento O&M Manual 137, August 1955, (Station 177+67)].

View of WS looking upstream.

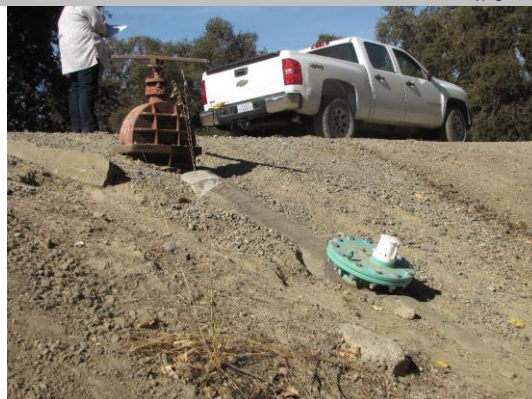
Photo 2 of 2 : UCIP_FA_2016_50474_70221.jpg

FS_ID:50474
DS_ID:16436
EP_NO: 4213
Repair Type: Urgent
Crossing Status: Found
UCIP Comments: 10/24/2016 Pump is on WS. Sinkhole still present over pipe alignment next to the concrete building.(DWR Sutter Yard-AFreitag)4/25/2016 No repairs have been made since last inspection. Sink holes are still present above pipe next to concrete building on LS. (DWR Sutter Yard - afreitag)4/20/2015 Sink hole over pipe alignment on LS up against the concrete building. Need to dig up pipe and see if its leaking. (DWR Sutter Yard - afreitag)6/23/2014 Same as last inspection. (DWR Sutter Yard - afreitag)6/18/2014 Same as last inspection. (DWR Sutter Yard - afreitag)12/17/2013 Same as last inspection. (DWR Sutter Yard - afreitag)7/18/2013 Same as last inspection. (DWR Sutter Yard - afreitag)10/19/2012 Recommend adding door to LS concrete structure. Riser located on landward side is damaged. This crossing was listed in the USACE Periodic Inspection as ID# USACE_CESPK_MA1C_2010_p_0194 no issues logged. (DWR UCIP - omagana)

Gate valve and exposed section of the pipe located on WS.

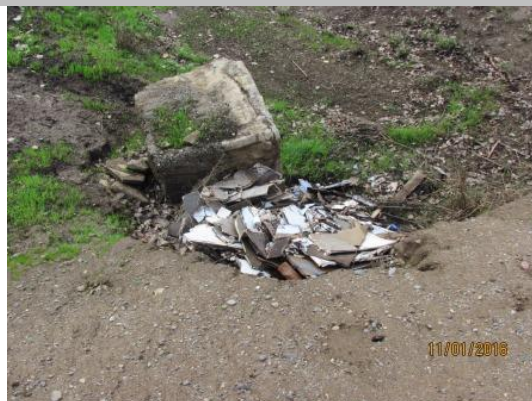
Photo 1 of 2 : FA_2016_MA0001_297_114_20161104_00171.jpg

View of the dry wall debris used for erosion control along the downstream side of the ramp.

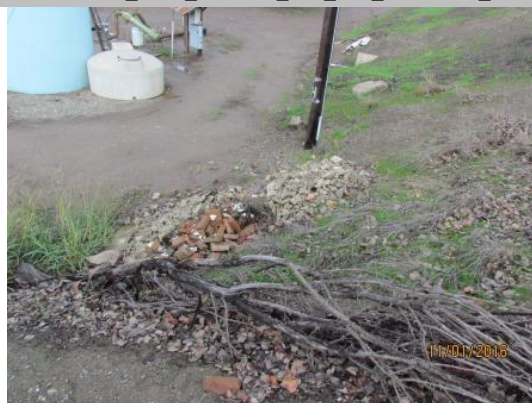
Photo 2 of 2 : FA_2016_MA0001_297_114_20161104_00172.jpg

View of the bricks and concrete debris along the upstream side of the ramp.

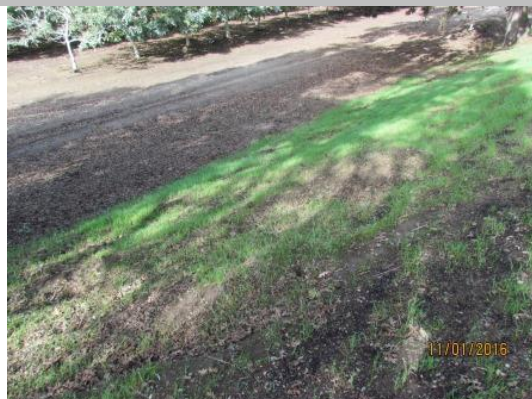
Photo 1 of 1 : FA_2016_MA0001_297_119_20161104_00174.jpg

View of the slope instability caused by vehicles along the landside slope.

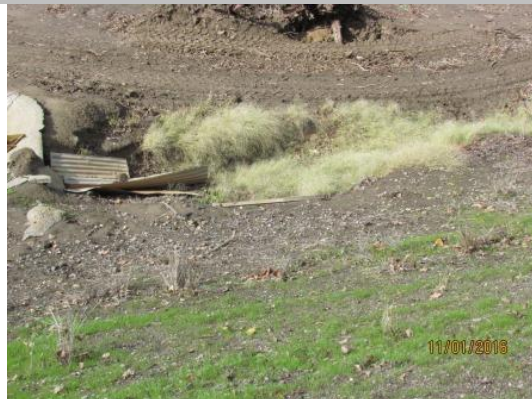
Photo 1 of 1 : FA_2016_MA0001_297_121_20161107_00176.jpg

View of the low spot along the levee toe created by adjacent ditch overflow.

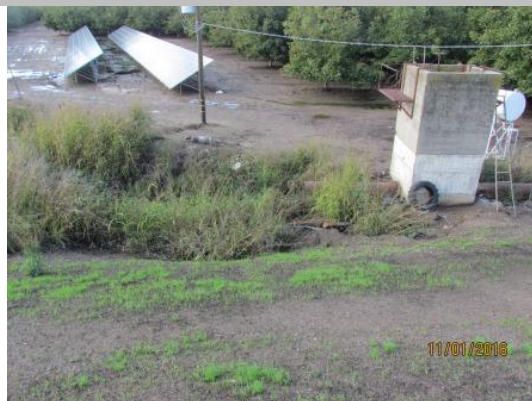
Photo 1 of 1 : FA_2016_MA0001_297_125_20161107_00180.jpg

View of the landside toe erosion caused by ag pipe.

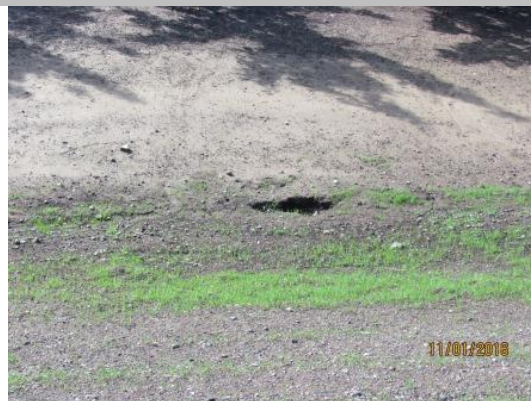
Photo 1 of 1 : FA_2016_MA0001_297_127_20161107_00182.jpg

View of a small sinkhole along the levee.

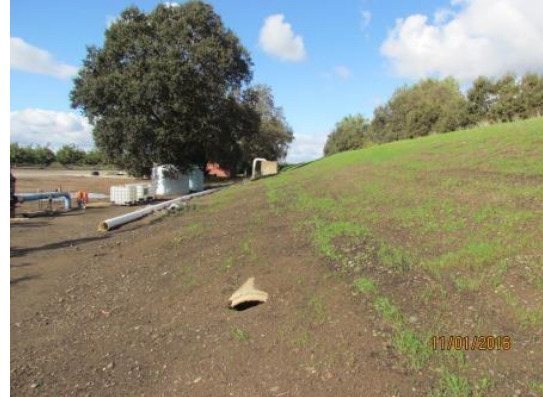
Photo 1 of 1 : FA_2016_MA0001_297_128_20161107_00183.jpg

View of a concrete pipe that runs along the levee toe.

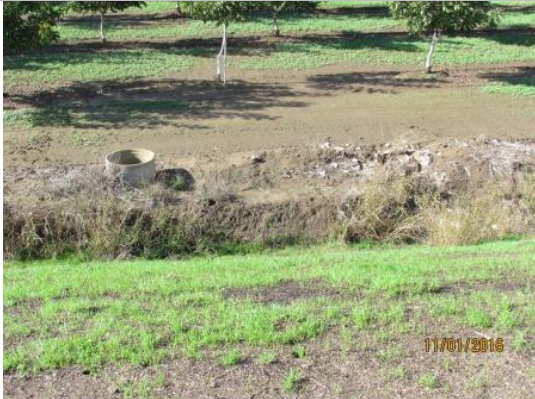
Photo 1 of 1 : FA_2016_MA0001_297_130_20161107_00185.jpg

View of a ditch along the landside toe.

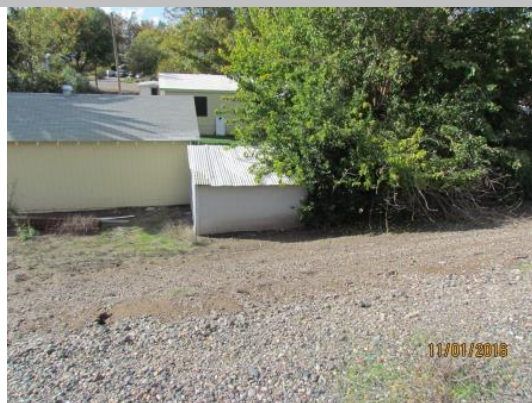
Photo 1 of 1 : FA_2016_MA0001_297_87_20161107_00187.jpg

View of a shed along the landside toe.
